# ASPHALT TECHNOLOGIES, INC.

## TEST & EVALUATION REPORT Shingle Rejuvenator Benchmark Life-Cycle Study

**Report For:** RoofRestor Rejuvenator  
Saskatchewan, Canada

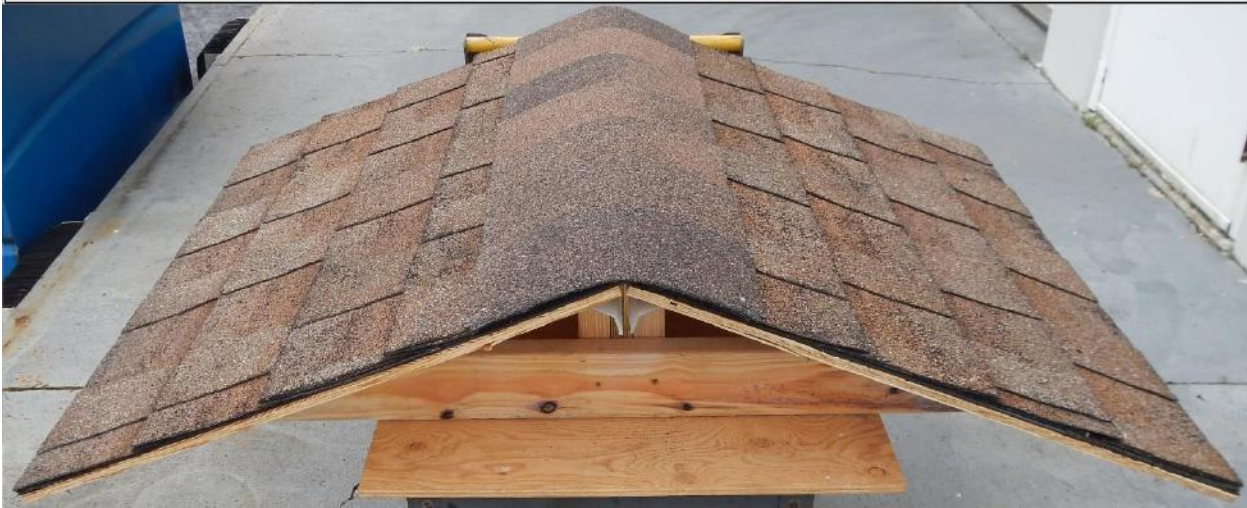
#### Completed Roof Deck Before Rejuvenator Application

A type of common, commercially used ridge-cap shingles were then cut and applied to the cap of the roof deck. The cap was selected for the closest visual match to the shingles used.

The study used a miniature steep sloped roof, constructed at PRI made with commonly used stock material (2X4's, plywood, peel-n-stick underlayment, and stainless-steel roofing nails). Both slopes were roofed with the aged shingles, with one side being treated with RoofRestor rejuvenator and the other side being an un-treated roof deck. The rejuvenator was applied according the manufacturer's recommendations. See appendix for photos and details of construction

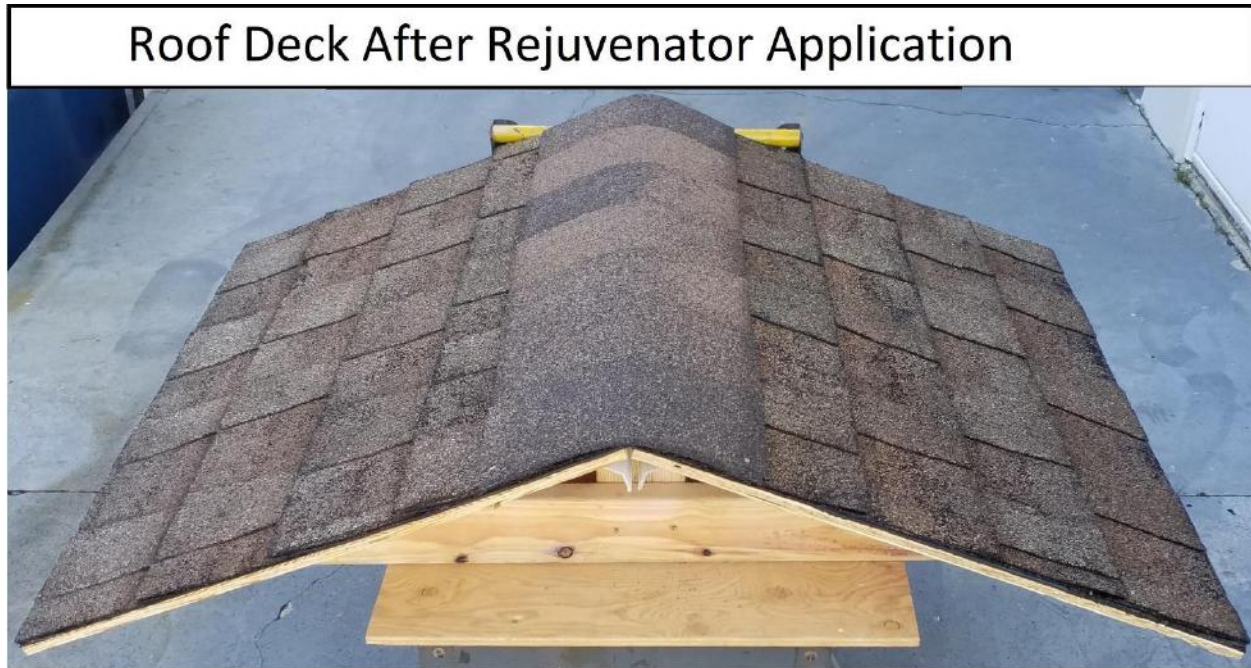
#### Application of Rejuvenators:

The RoofRestor Rejuvenator was prepared and applied according to manufacturer guidelines using common garden spray bottles and allowed to cure for 24 hours:

- Manufacturer recommendations – A mixture of 70% water and 30% Rejuvenator concentrate stirred by hand to homogeneity.
- The product was applied were to one side of the roof deck at a target rate of 1 gallon per 100ft<sup>2</sup> using simple spray bottles.
- The other side was left un-treated.

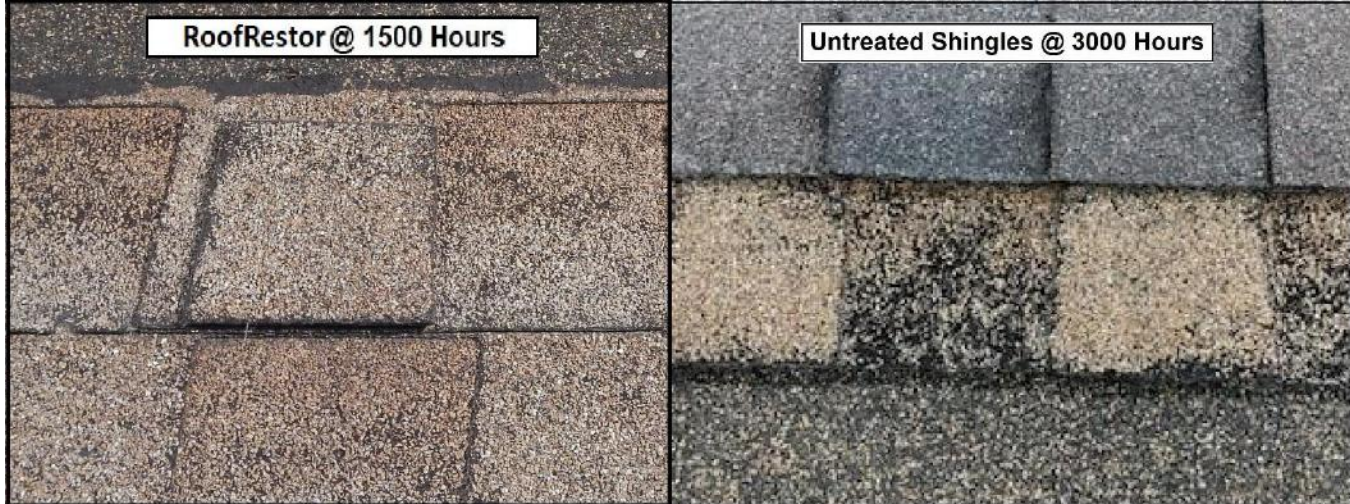
### APPENDIX A-5 (Shingle Appearance Comparison – ~3000 hours):

There is a notable difference in appearance between the untreated and treated shingles after 3000 Hours.

- Un-treated shingles show a clear increase in the roofing granules lost. (Appendix A-4/5)

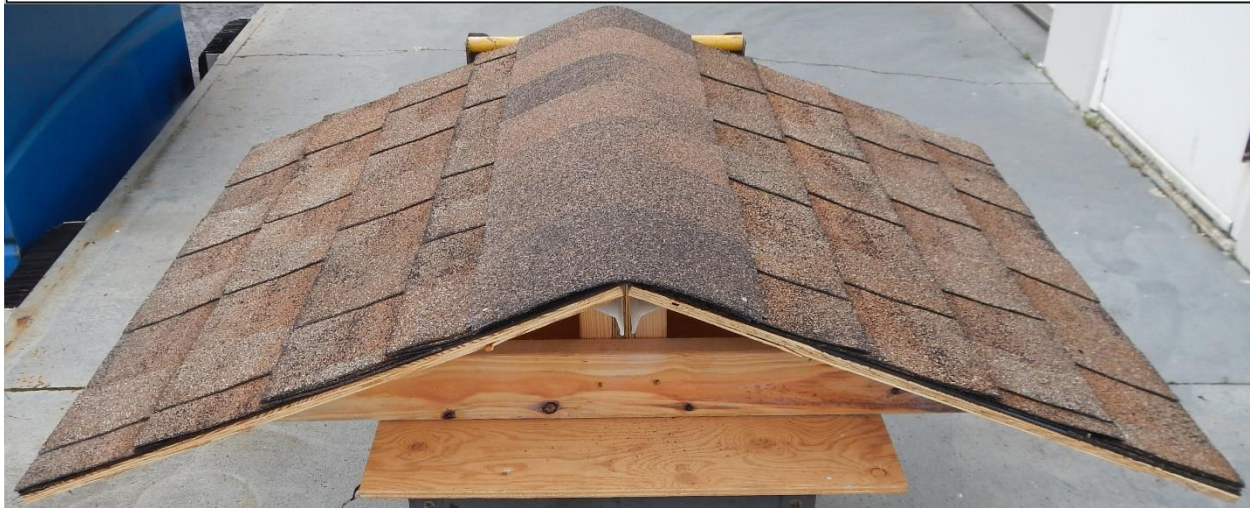
#### Completed Roof Deck Before Rejuvenator Application

A type of common, commercially used ridge-cap shingles were then cut and applied to the cap of the roof deck. The cap was selected for the closest visual match to the shingles used.

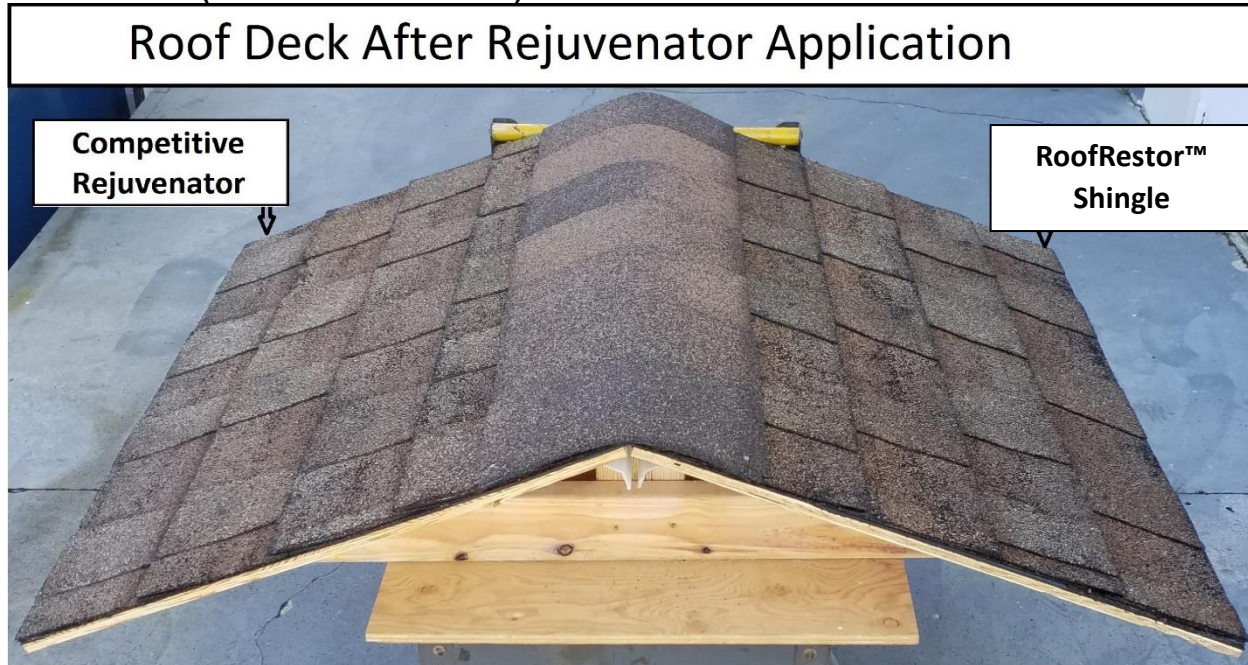
### APPENDIX A-2 (Roof Deck Construction):

Both rejuvenators were prepared and applied according to manufacturer guidelines using common garden spray bottles and allowed to cure for 24 hours:

- Competitive rejuvenator – A mixture of 50% water and 50% Rejuvenator concentrate stirred by hand to homogeneity
- RoofRestor™ Shingle Rejuvenator – A mixture of 70% water and 30% Rejuvenator concentrate stirred by hand to homogeneity
- Both diluted products were applied to their respective side of the roof deck at a target rate of 1 gallon per 100ft<sup>2</sup> using simple spray bottles.

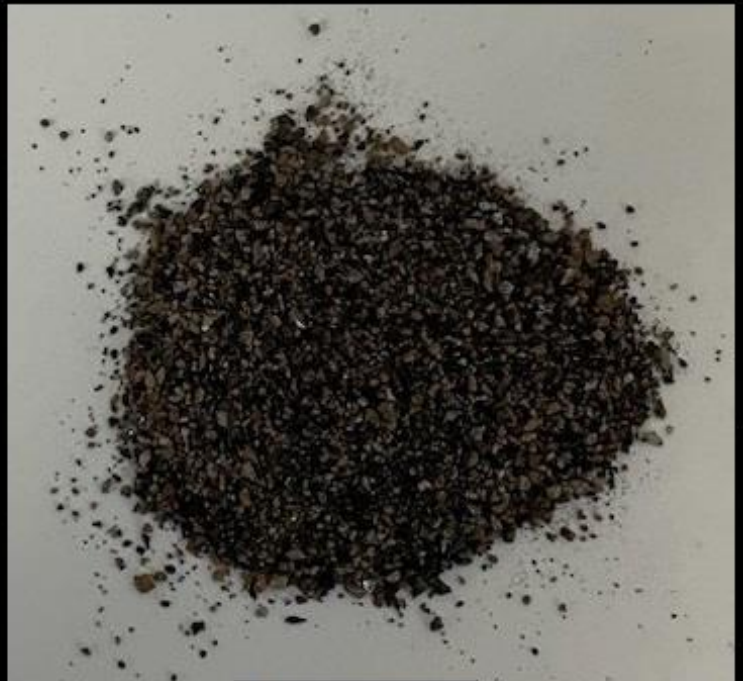
APPENDIX A-5 (Granular Wash off Comparison – ~3000 hours):

RoofRestor™ Shingle	Competitive Rejuvenator
  <p data-bbox="337 1192 570 1255"><b>3.94 grams</b></p>

<p data-bbox="997 1192 1229 1255"><b>9.86 grams</b></p>

Granules and particulate washed from the roof decks after 3000 hours of exposure. Particles have been filtered from the accompanying runoff water and dried for quantification.

- **RoofRestor™ Shingle Rejuvenator performs 2.5 times better than the competition.**
  - After 3,000 hours of exposure the mass of the collected particulate from the competitive rejuvenator was 9.86g compared to 3.94g for the RoofRestor™ Shingle Rejuvenator.

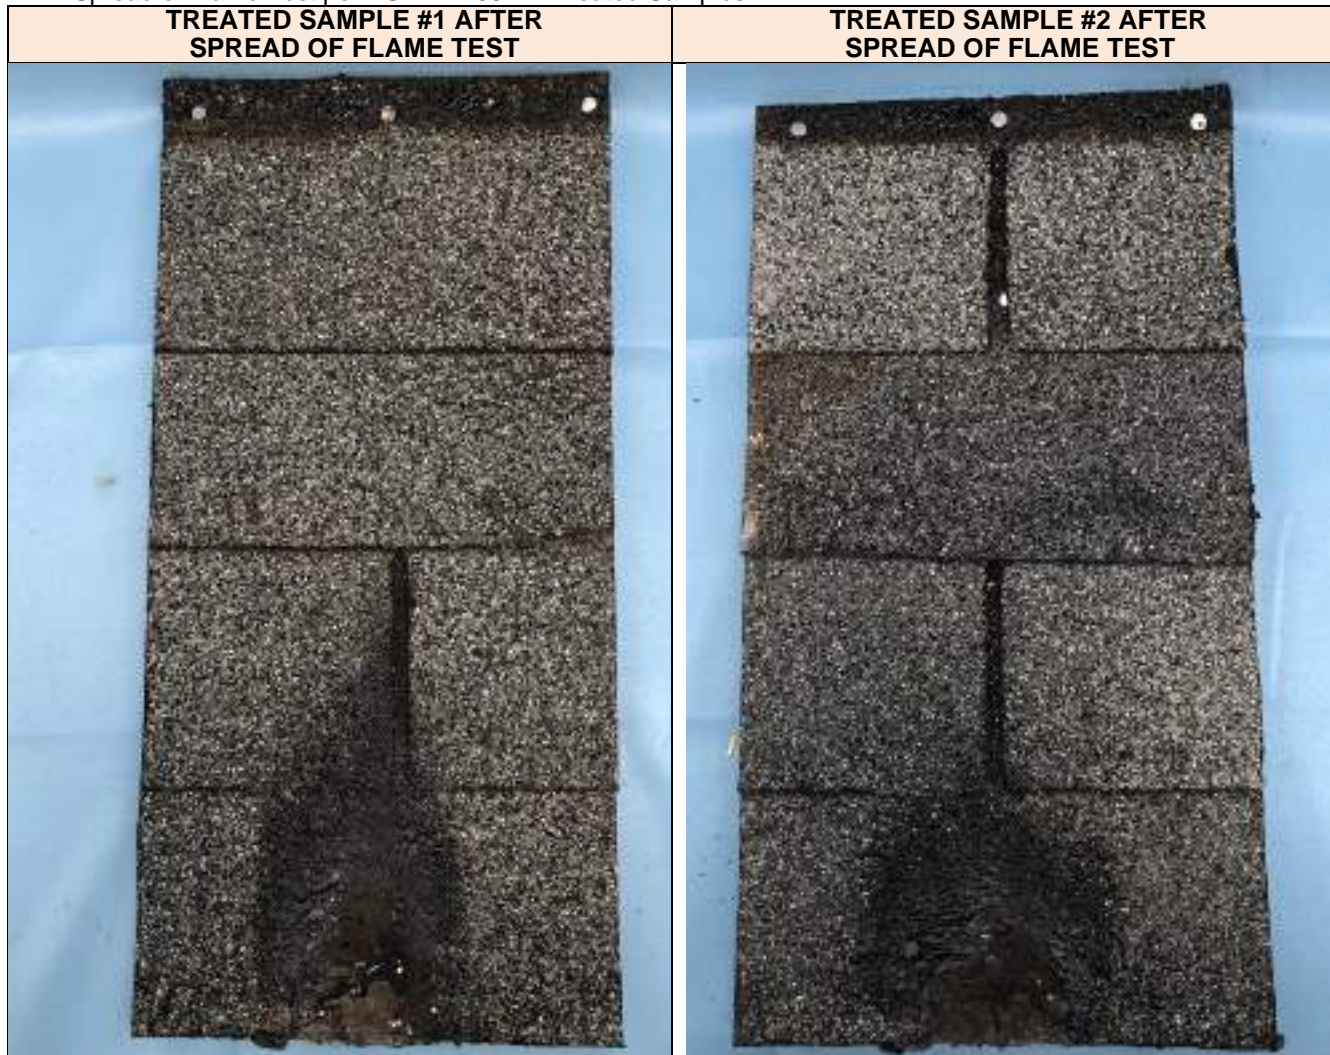
### A1. Spread of Flame Test per ASTM E108M – Treated Samples

Spread of flame covered less surface area (a distinct benefit). This is worthy of further investigation.

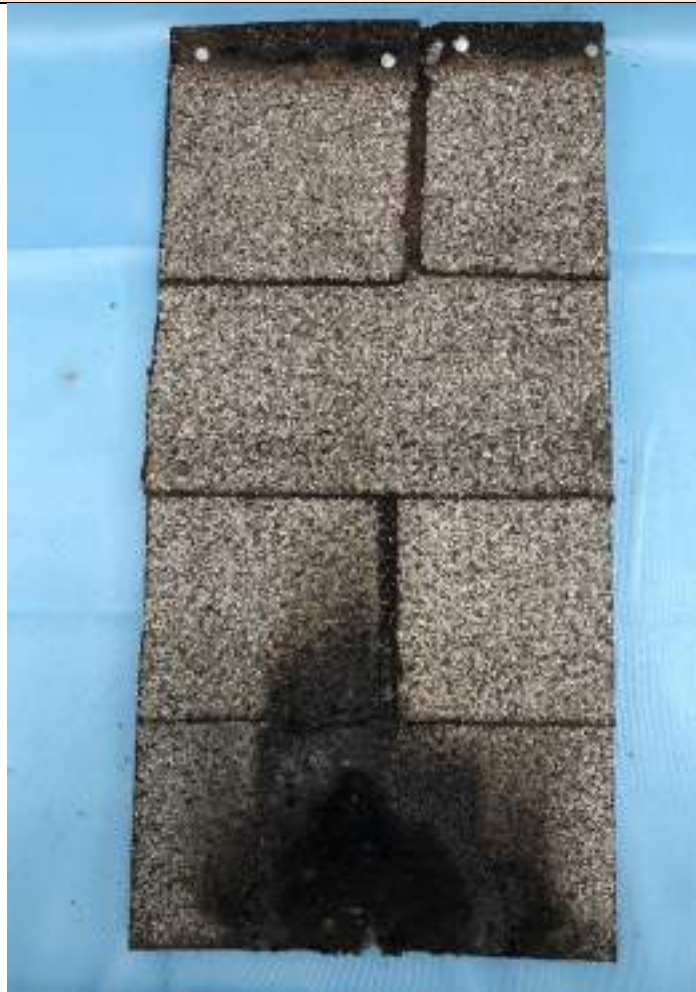
**A2. Spread of Flame Test per ASTM E108M – Untreated Samples**

**- UNTREATED SAMPLE #3 AFTER  
SPREAD OF FLAME TEST**

The control exhibited significantly more spread and damage than the treated shingles.

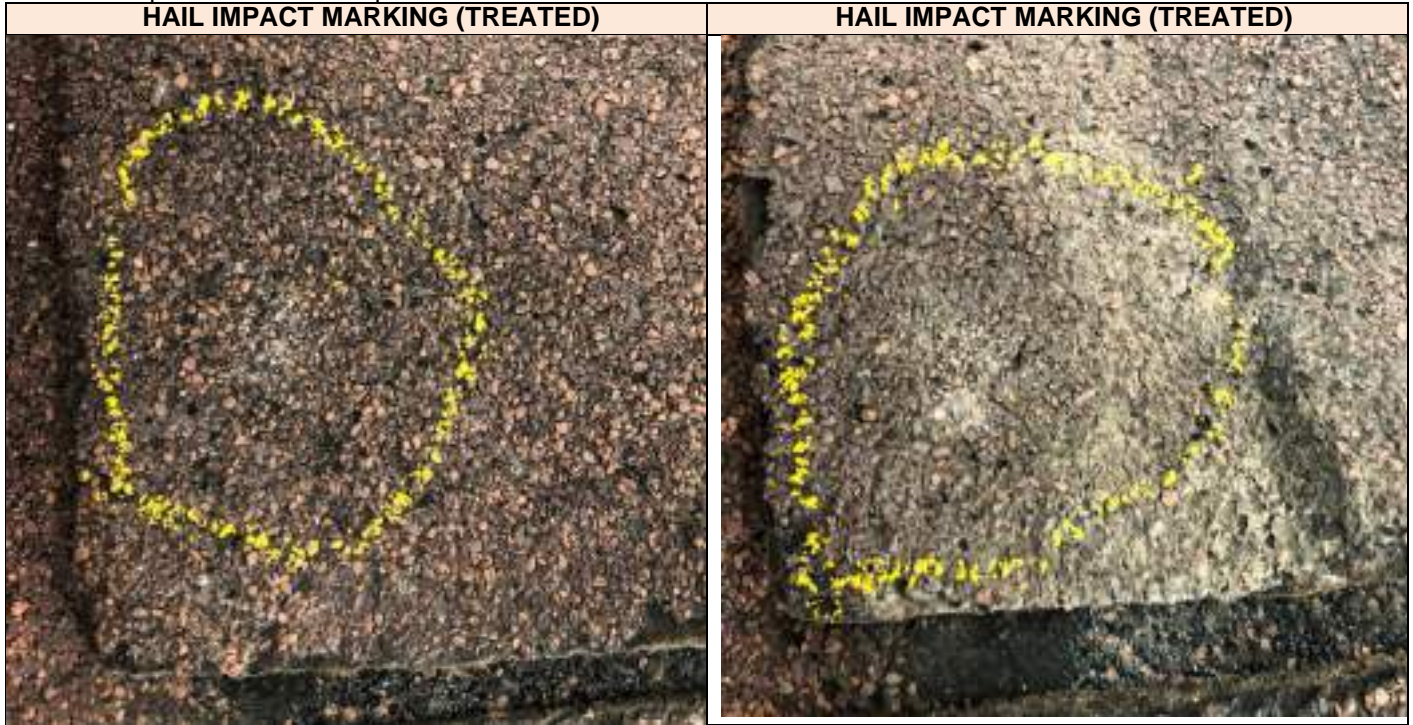
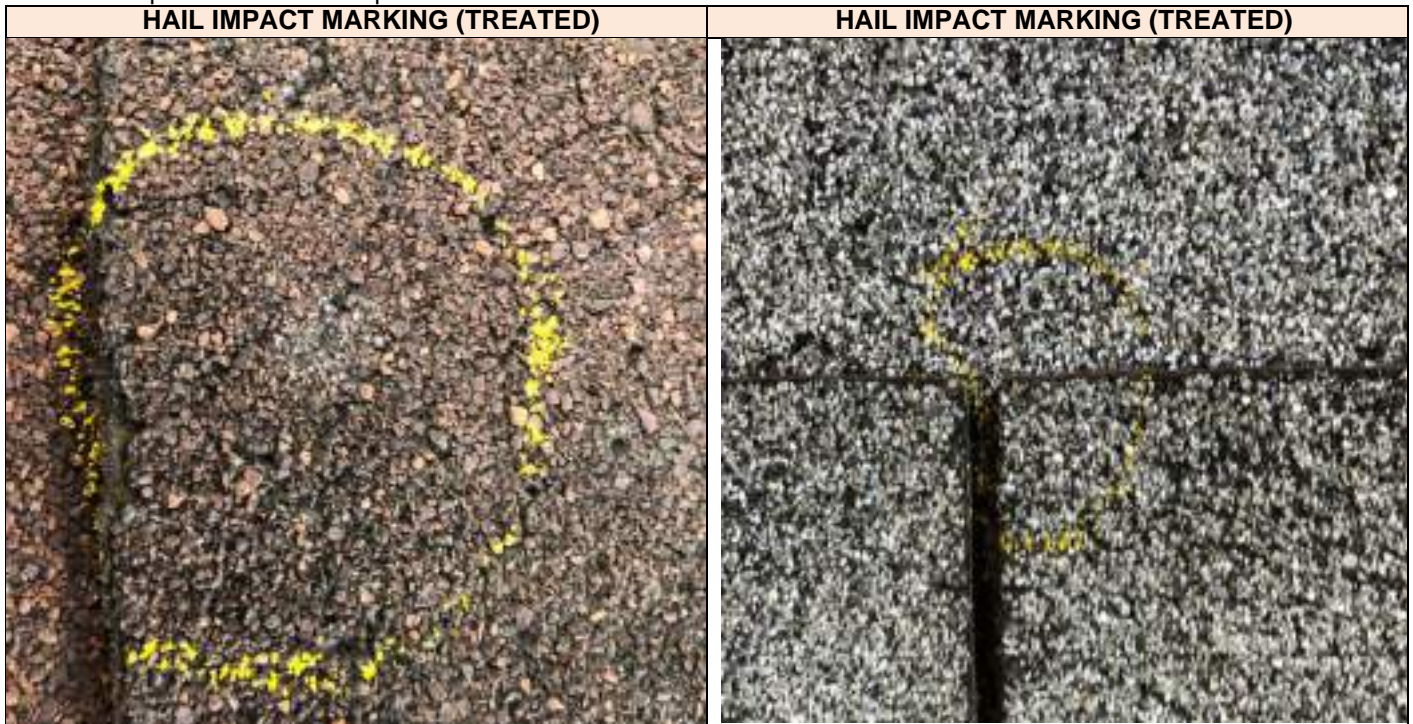
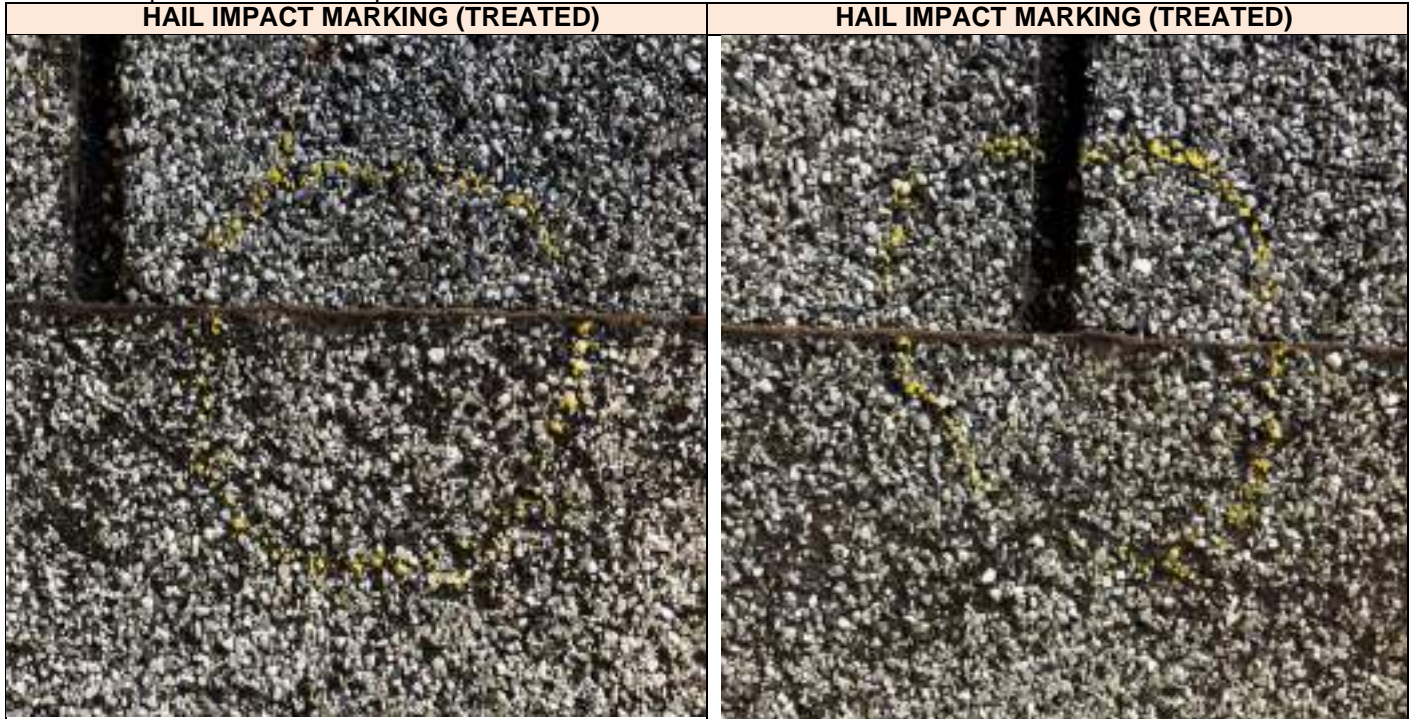
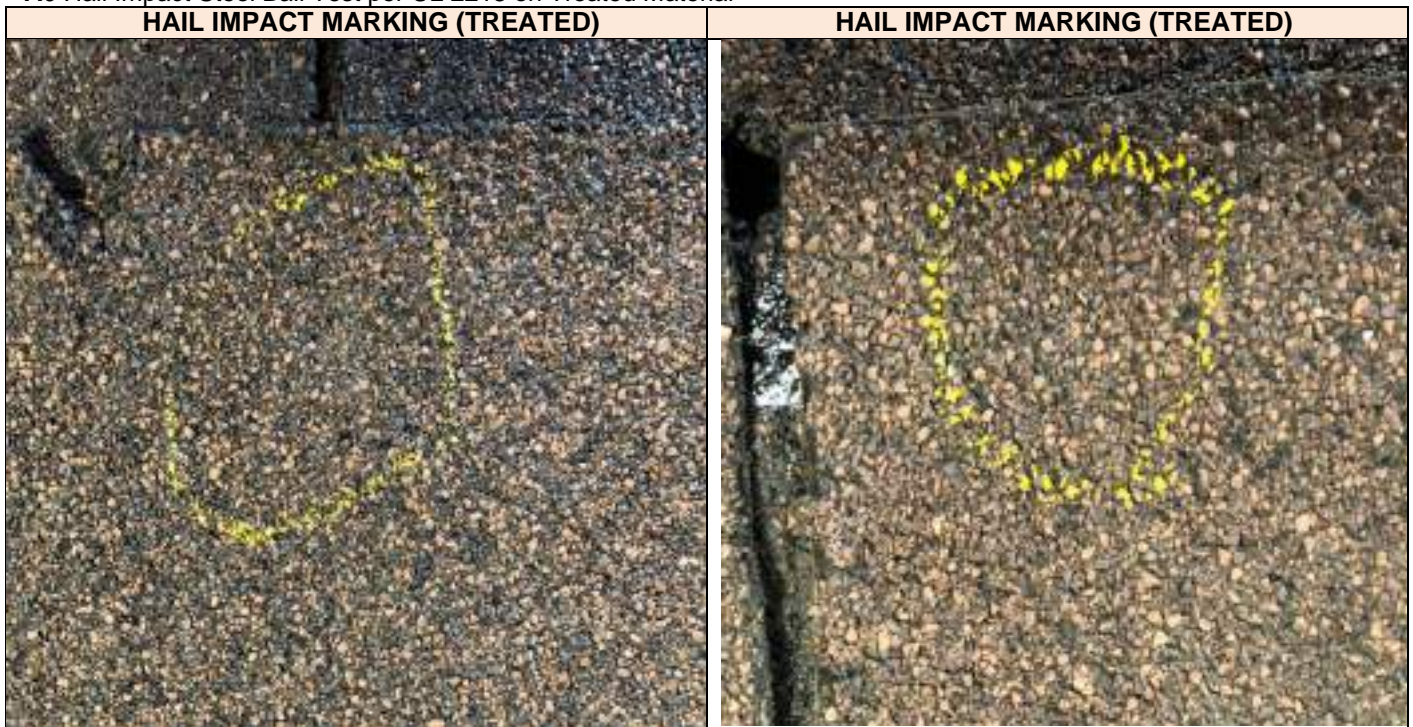
**A3. Hail Impact Steel Ball Test per UL 2218 on Treated Material**

**A4. Hail Impact Steel Ball Test per UL 2218 on Treated Material**

**A5. Hail Impact Steel Ball Test per UL 2218 on Treated Material**

**A6 Hail Impact Steel Ball Test per UL 2218 on Treated Material**

Because the test shingles were organic felt based, the criteria for Hail Impact Resistance; cracking, and damage to the shingle surface was not observed.

Consequently, we included photos exhibiting the results on the granular surface. The results were mixed primarily due to the severely aged conditions of the test shingles. However, the treatment appeared to re-adhere the granules, which reduced the surface damage some.

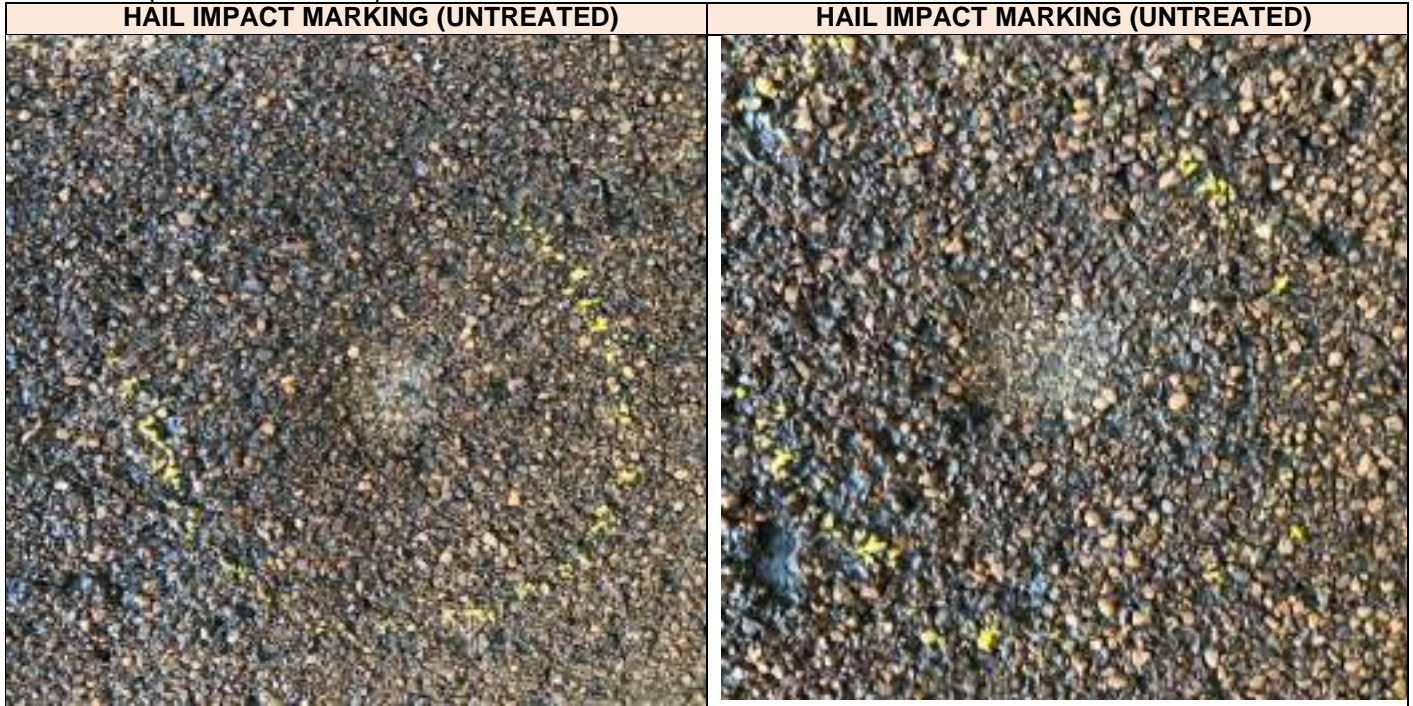
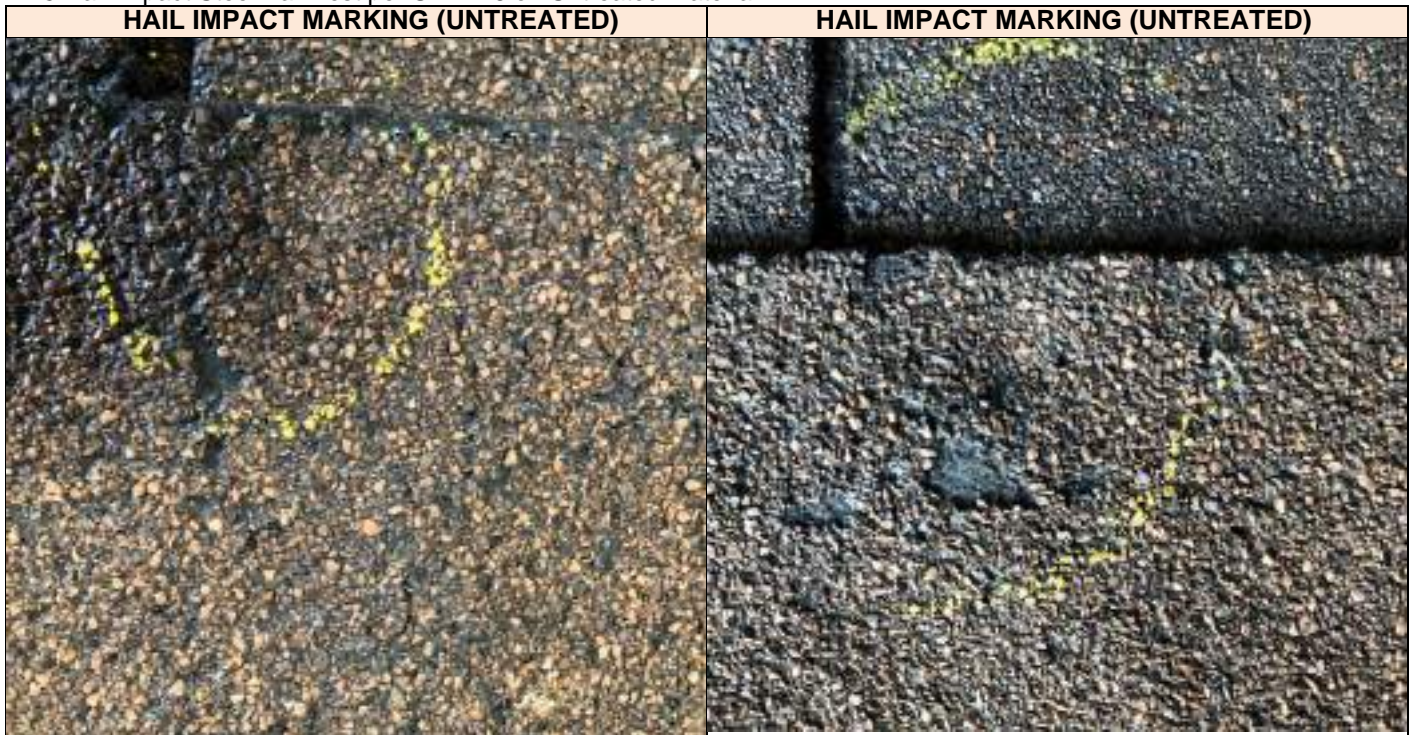
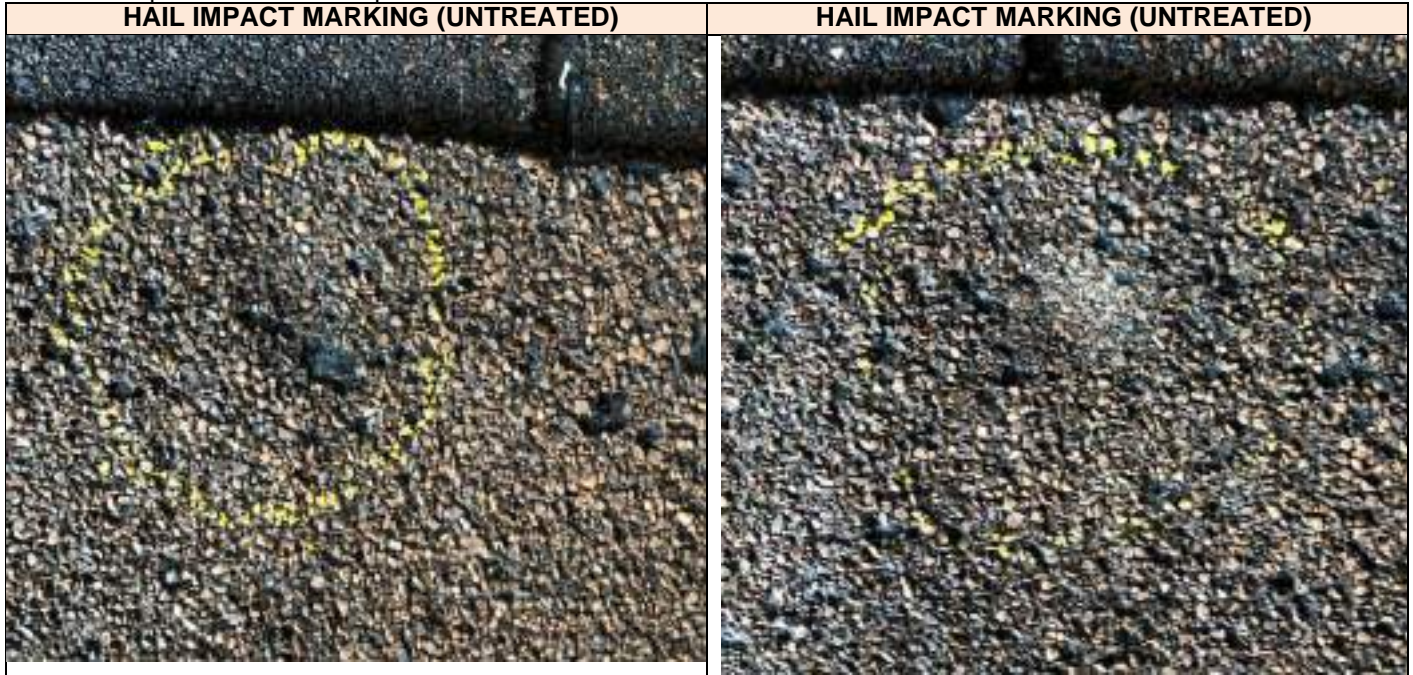
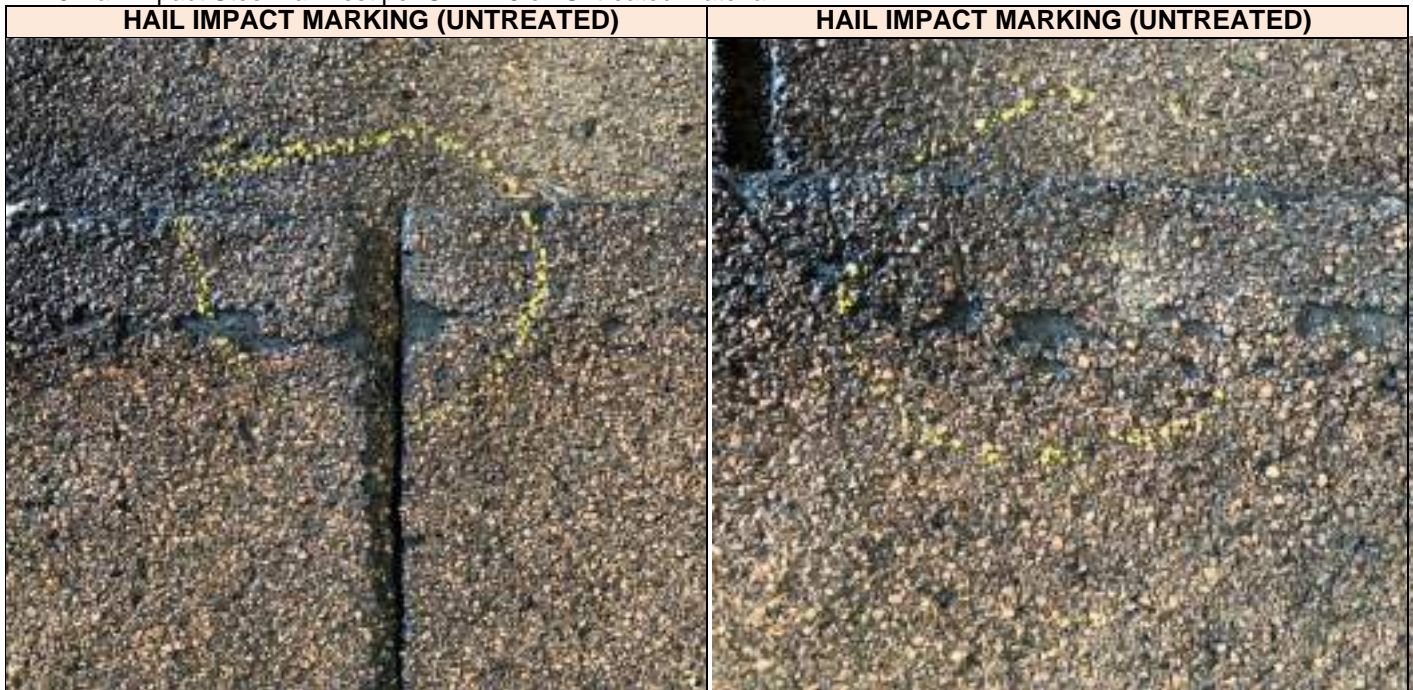
**A7. Hail Impact Steel Ball Test per UL 2218 on Untreated Material**

**A8 Hail Impact Steel Ball Test per UL 2218 on Untreated Material**

**A9. Hail Impact Steel Ball Test per UL 2218 on Untreated Material**

**A10 Hail Impact Steel Ball Test per UL 2218 on Untreated Material**
